1.1. Background

On April 26 at lunchtime, 112 calls are received to SOS Alarm/LC about fire/smoke development from a larger container that contains lithium-ion batteries and is located indoors at a company in Sisjön's industrial area. When the emergency services arrive at the property continued fire/smoke development is noted, however, the company's staff have managed to move out the container from the building.

3.1.1 Description of the battery energy storage

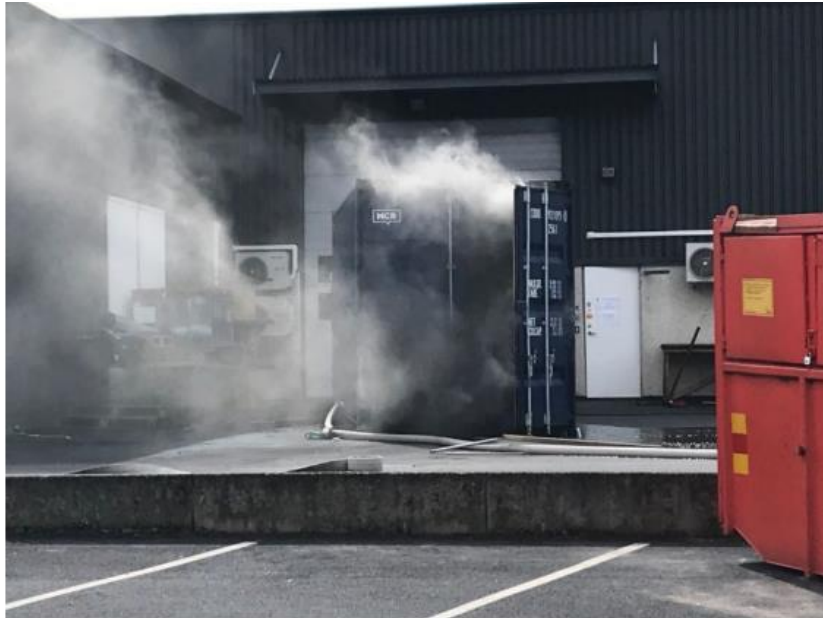
completely, which they soon after succeeded in doing. The container was now outside the building and the fire personnel saw that the door on the end of the container was open there white smoke came out. Personnel from the company described the contents of the container to the force leader and that there was an entry for extinguishing water on the long side of the container, this to be able to sprinkle and fill the container with water if necessary and thus destroy all batteries inside the container. This entry was connected but not started.

Figure 2 shows the container early in the operation. Source RSG

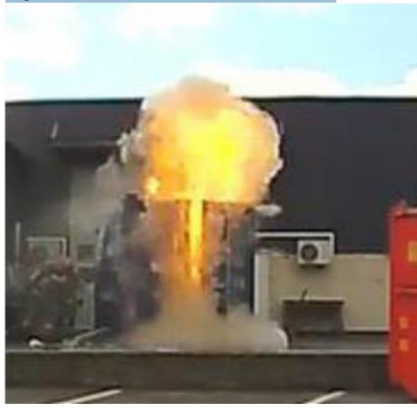
Cooling/inerting of the battery and its surroundings had begun with cutting extinguishers and with it you shot diagonally upwards towards the roof of the container to avoid hitting the battery. IL continued as rescue manager (RL) and in connection with a short management meeting, about 4 – 5 minutes after cooling with cutting extinguishers started, a strong one occurred explosion that deformed the container and where the doors on one short side of the container flew open.

Figure 3 shows a clip from a film that captured the explosion. Source current company.

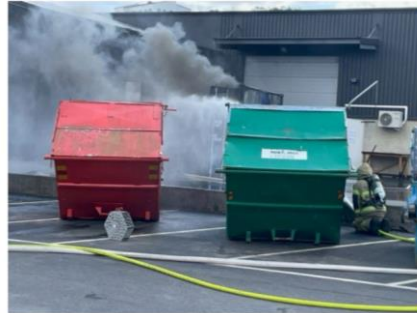
Figure 4 shows smoke development and work from a protected position. Source RSG

In connection with the explosion, the development of smoke increased significantly and they could now see openings flames from the batteries. The new orientation meant that now resources were also put into limit the fire's spread to adjacent buildings. This was carried out with cooling of facades and roofs with water from jet pipes and water cannons.
